TECHNICAL ASSISTANCE TEAM FOR EMERGENCY RESPONSE REMOVAL AND PREVENTION
EPA CONTRACT 68-01-7367

Re: Schmidt's Brewery Site Assessment, Cleveland, Ohio
TDD# 5-9003-21

**SITE ASSESSMENT
SCHMIDT'S BREWERY
CLEVELAND, OHIO**

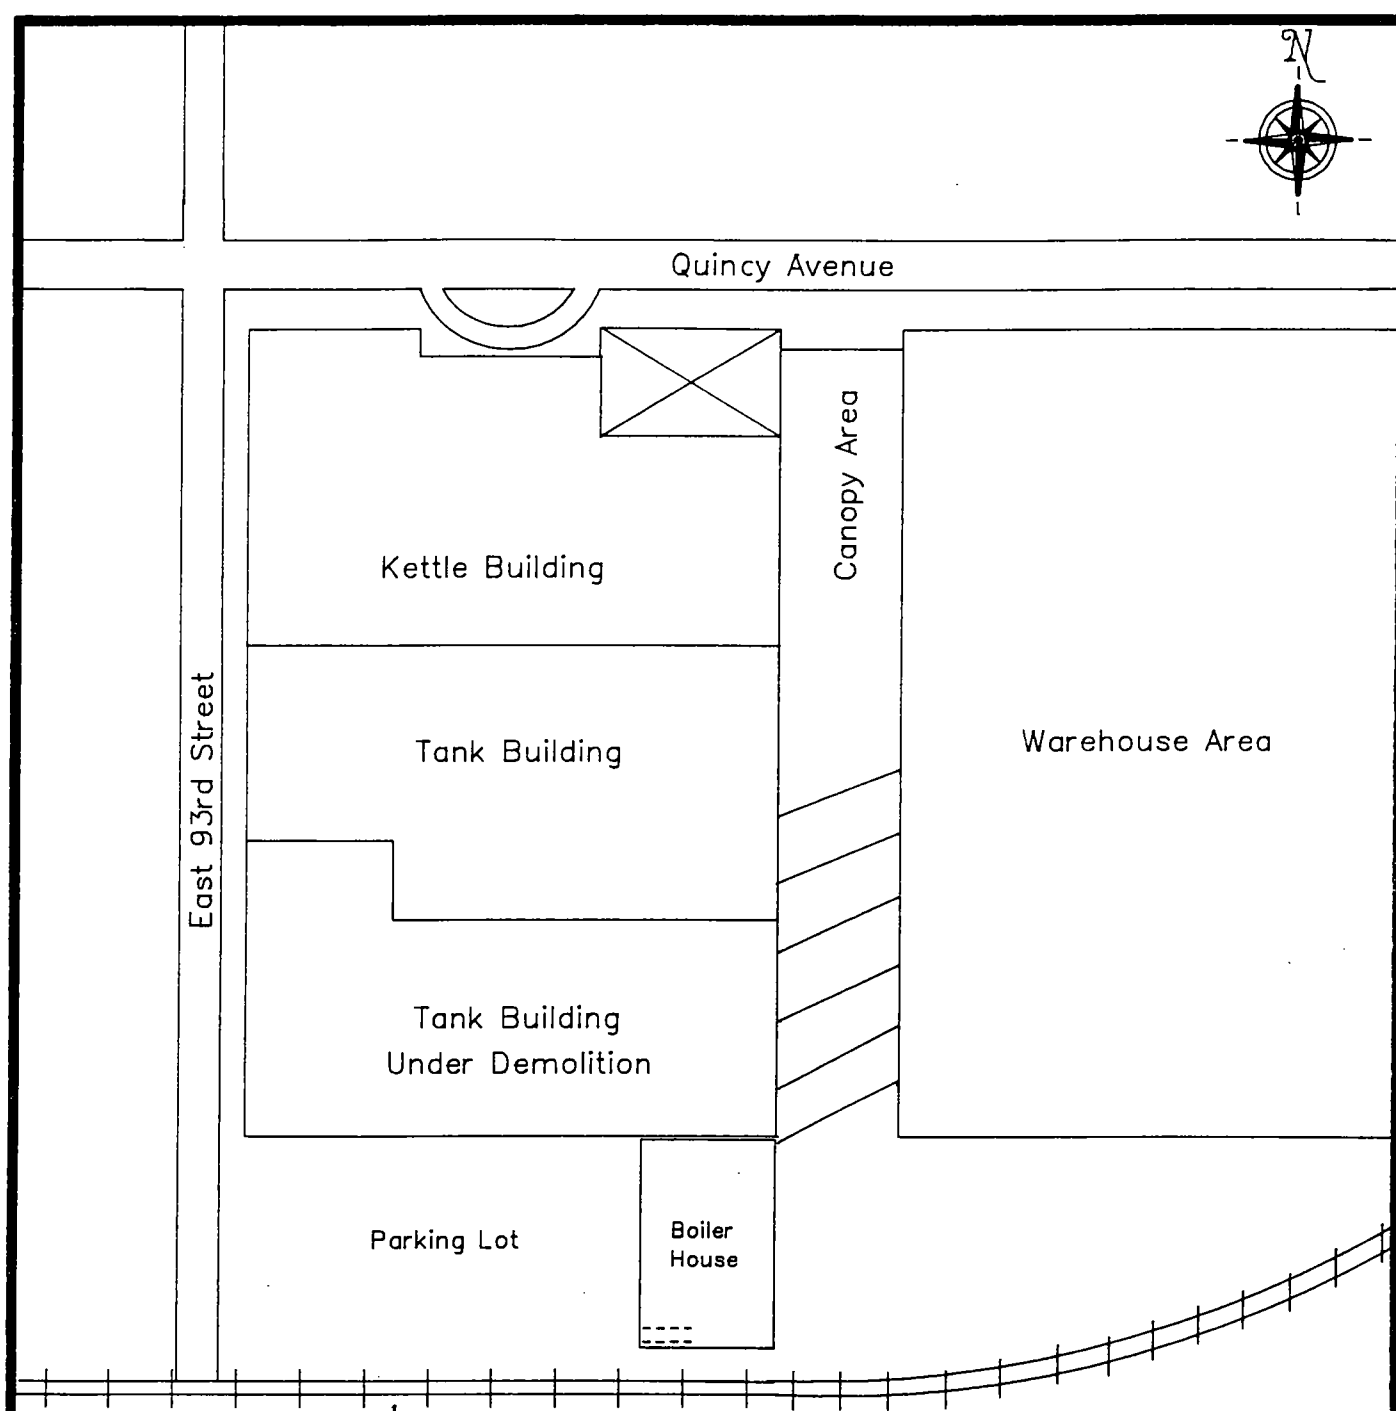
FIGURE 2

The facility is comprised of a kettle building, two tank buildings, a boiler house, and a canopy area (Figure 2). A tank building and part of the canopy have been partially demolished to facilitate removal of several large stainless steel tanks. The predominant contaminant of concern is asbestos containing material (ACM); this material is located throughout the facility.

SITE MAP

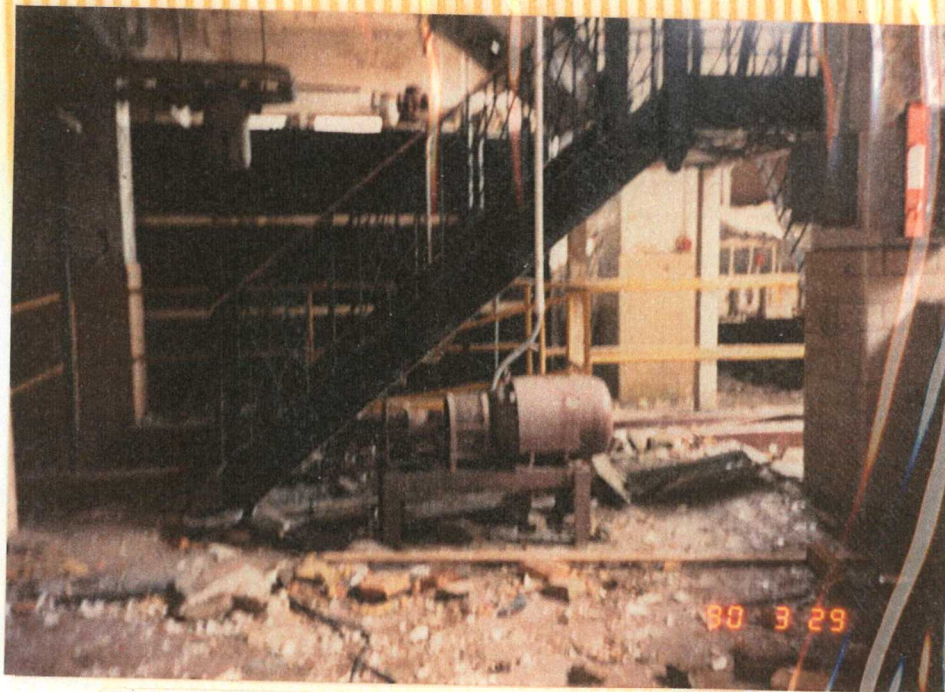
PHOTO:1	PCS# 2664
ROLL/PICTURE:	1/2
SITE NAME:	SCHMIDT'S BREWERY
DESCRIPTION:	1ST FLOOR OF KETTLE BLDG. SHOWING DEBRIS & DRY FRIABLE MATERIAL.
DATE/TIME:	3-29-90 / 1133
PHOTOGRAPHER:	MALSCH <i>MM</i>
FILM:	35MM, 200 ASA, NO ATTACHMENTS

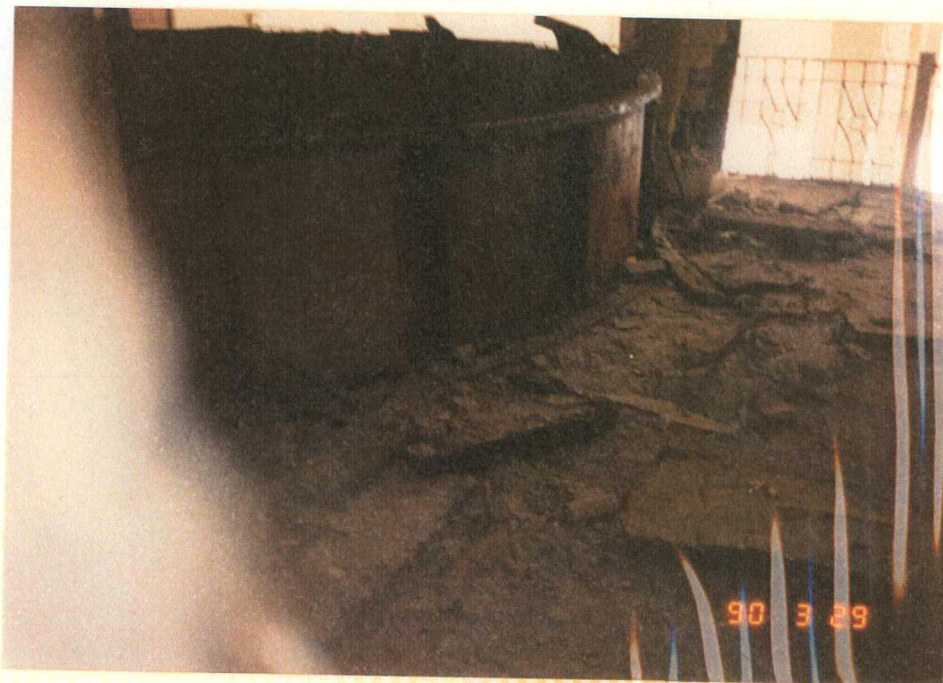
PHOTO:2	PCS# 2664
ROLL/PICTURE:	1/5
SITE NAME:	SCHMIDT'S BREWERY
DESCRIPTION:	3RD FLOOR OF KETTLE BLDG. SHOWING LARGE QUANTITIES OF DRY FRIABLE MATERIAL.
DATE/TIME:	3-29-90 / 1138
PHOTOGRAPHER:	MALSCH <i>MM</i>
FILM:	35MM, 200 ASA, NO ATTACHMENTS

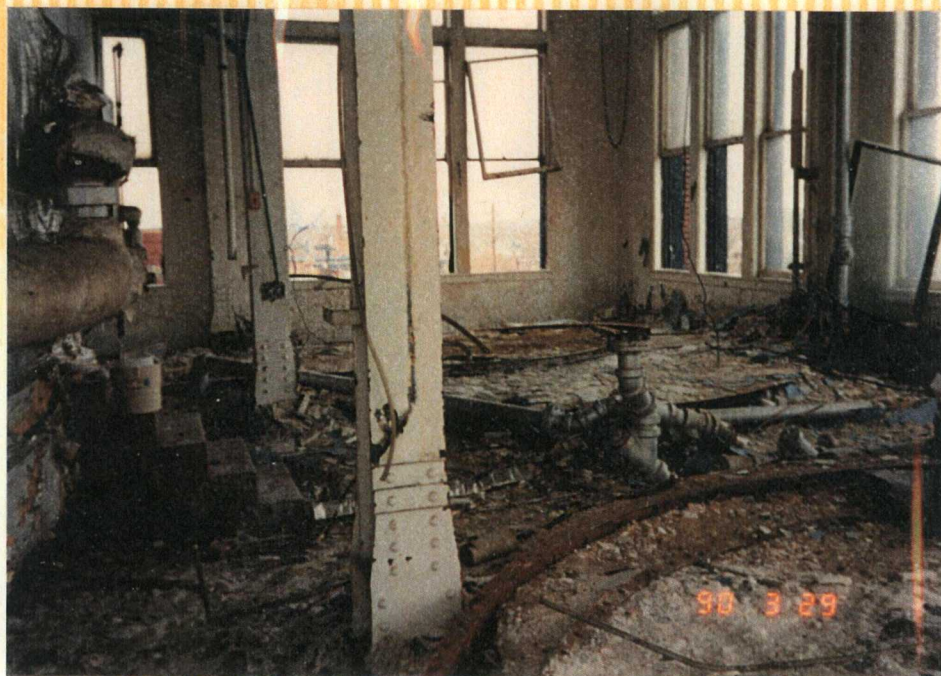
The fourth floor of the kettle building contained several grain storage bins as well as large amounts of debris and ACM left from the removal of two kettles (Figure 3). In addition, six of the ten north windows, eight of the twelve east windows, and all six of the west windows were broken.

PHOTO:3	PCS# 2664
ROLL/PICTURE:	1/6
SITE NAME:	SCHMIDT'S BREWERY
DESCRIPTION:	4TH FLOOR OF KETTLE BLDG. SHOWING LARGE QUANTITIES OF ACM.
DATE/TIME:	3-29-90 / 1140
PHOTOGRAPHER:	MALSCH <i>pm</i>
FILM:	35MM, 200 ASA, NO ATTACHMENTS

1. Seal kettle building windows with plywood or plexiglass
2. Wet and cover all ACM
3. Begin ACM removal with a qualified abatement crew

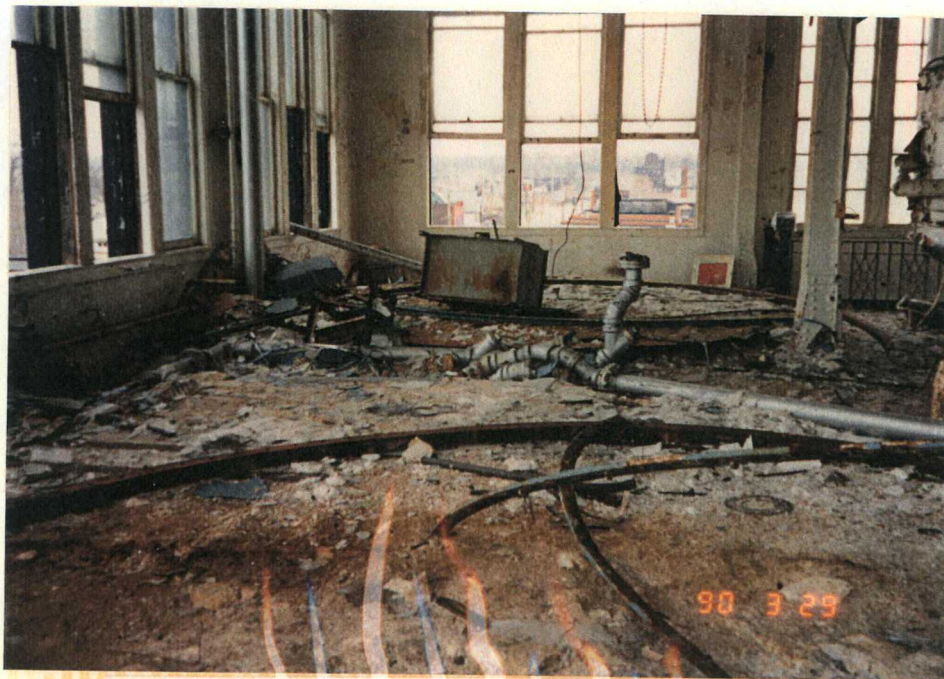
PHOTO:4	PCS# 2664
ROLL/PICTURE:	1/7
SITE NAME:	SCHMIDT'S BREWERY
DESCRIPTION:	4TH FLOOR OF KETTLE BLDG. SHOWING LARGE QUANTITIES OF ACM.
DATE/TIME:	3-29-90 / 1142
PHOTOGRAPHER:	MALSCH <i>pm</i>
FILM:	35MM, 200 ASA, NO ATTACHMENTS

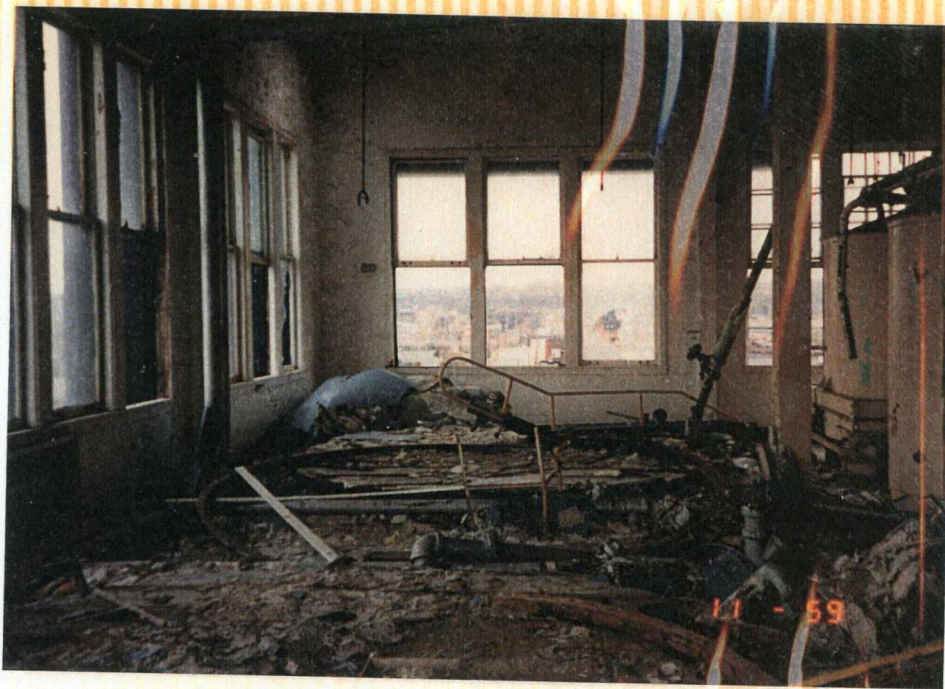
The fifth floor of the kettle building also contained large amounts of debris and ACM remaining after the salvage of kettles. TAT collected a composite, bulk sample of the friable material surrounding the salvaged kettles (Figure 4) for asbestos analysis.

PHOTO:5 PCS# 2664
 ROLL/PICTURE: 1/10
 SITE NAME: SCHMIDT'S BREWERY
 DESCRIPTION: 5TH FLOOR OF KETTLE BLDG. SHOWING DEBRIS & ACM LEFT FROM KETTLE SALVAGE.
 DATE/TIME: 3-29-90 / 1159
 PHOTOGRAPHER: MALSCH *MM*
 FILM: 35MM, 200 ASA, NO ATTACHMENTS

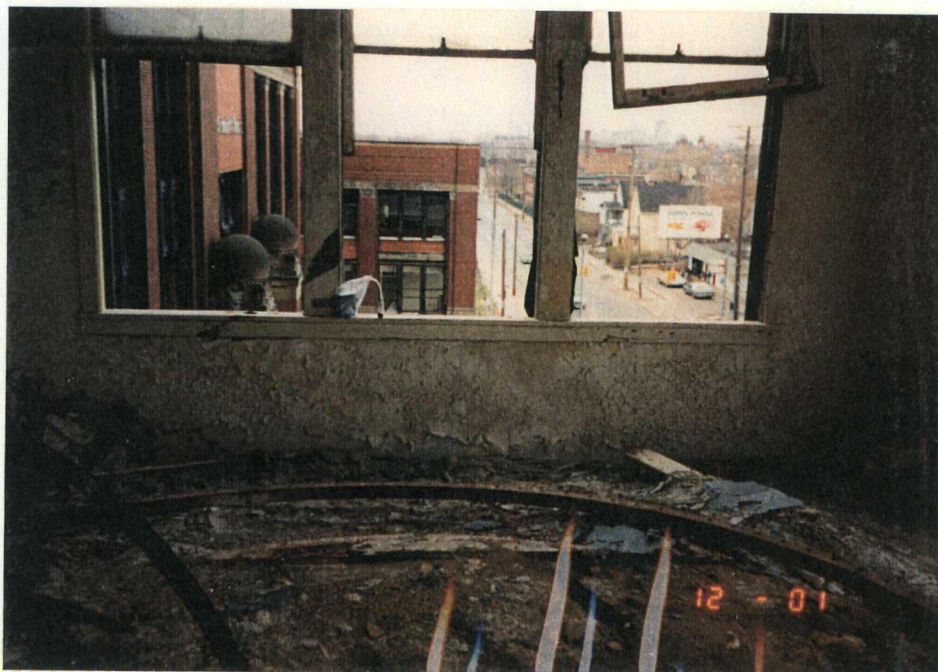
To determine if ACM was migrating from the kettle building, TAT collected air samples from the west and east window ledges of the fourth floor (Figure 3). Using a Gilian HFS 113A air pump, 630 liters of air were pulled through a cellulose filter (pore size = 0.45 μm) at a rate of 3.5 liters per minute (l/min.). During the sample period, humidity was high and a steady rain fell. A blank air sample for asbestos was collected and analyzed for quality assurance purposes. In addition, TAT collected a bulk sample of the debris surrounding the salvaged kettles (Figure 3) for asbestos analysis.

PHOTO:6 PCS# 2664
 ROLL/PICTURE: 1/11
 SITE NAME: SCHMIDT'S BREWERY
 DESCRIPTION: GILIAN PUMP ON THE WINDOW LEDGE OF THE 4TH FLOOR OF THE KETTLE BLDG.
 DATE/TIME: 3-29-90 / 1502
 PHOTOGRAPHER: MENCIN *MM*
 FILM: 35MM, 200 ASA, NO ATTACHMENTS

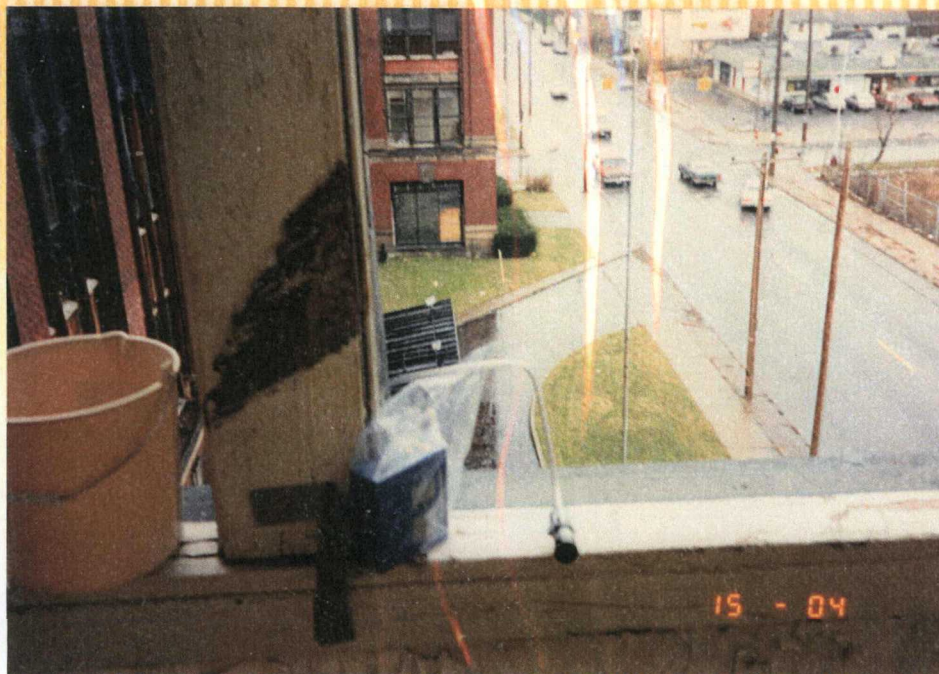
PHOTO:7	PCS# 2664
ROLL/PICTURE:	1/15
SITE NAME:	SCHMIDT'S BREWERY
DESCRIPTION:	VIEW OF RECEPTACLE FROM THE 4TH FLOOR WINDOW OF THE KETTLE BLDG.
DATE/TIME:	3-29-90 / 1504
PHOTOGRAPHER:	MENCIN <i>[signature]</i>
FILM:	35MM, 200 ASA, NO ATTACHMENTS

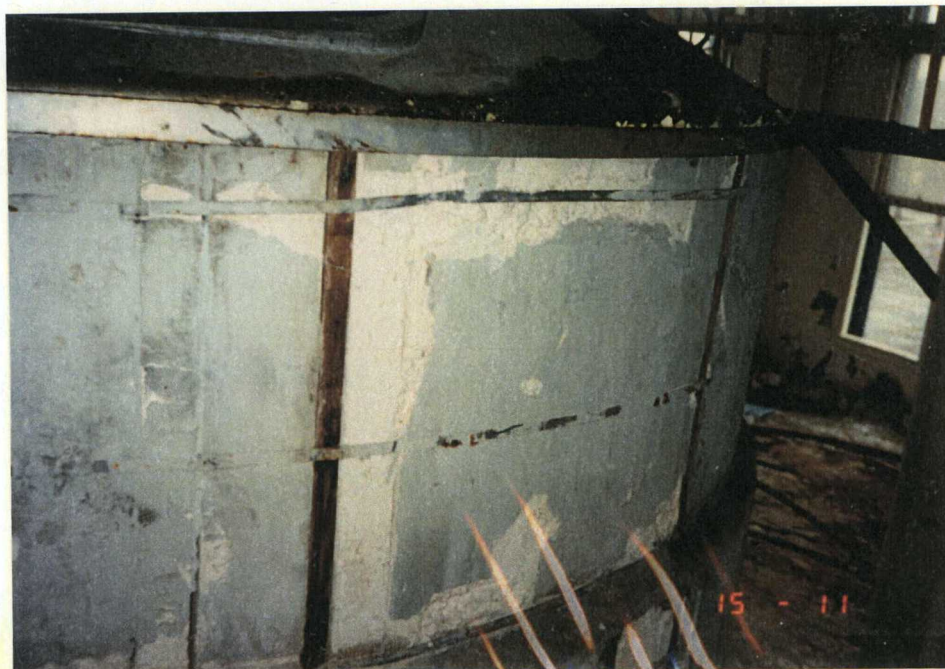
PHOTO:8	PCS# 2664
ROLL/PICTURE:	1/19
SITE NAME:	SCHMIDT'S BREWERY
DESCRIPTION:	VIEW OF KETTLE WITH SUSPECTED ACM INSULATION.
DATE/TIME:	3-29-90 / 1511
PHOTOGRAPHER:	MENCIN <i>[signature]</i>
FILM:	35MM, 200 ASA, NO ATTACHMENTS
